# HPS Components Used to Repair Competitor Pumps, Increased Injection Rate by 15%, Saved \$800,000 USD

**Costayaco Field, Colombia**

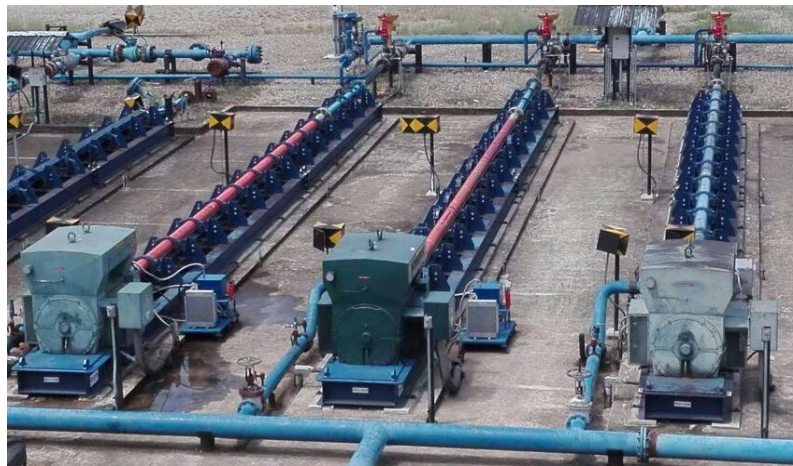
*Novomet components used to replace only the failed components in a competitor HPS installation.*

Novomet replaced the failed pump sections with our multistage centrifugal pumps capable of handling up to 60% free gas. We also replaced the damaged thrust chambers, added a cooling system to increase runlife, and adjusted the skid, piping, control, and power systems. This solution left the competitor motor, skid, and coupling in place, replacing only the components needed to get the pumps back online. The entire operation was completed in 2 days, putting the water flood operation back on production.

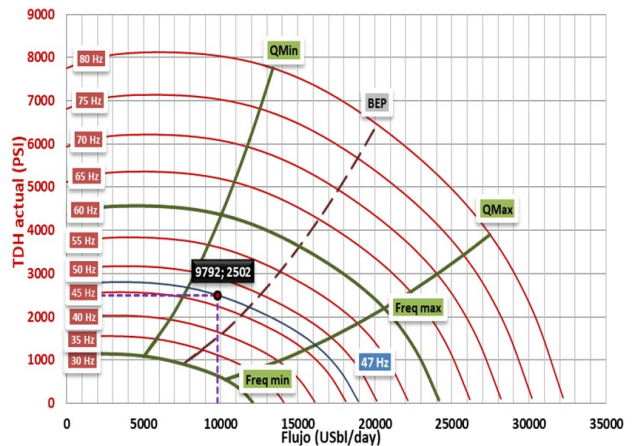
Novomet HPS components were selected because they consume 10% less power, cost 15% less, and produce 10% more discharge pressure than the failed competing pumps.
